**HGT BELLHOUSING**  
**INSTALLATION GUIDELINES**  
**VERNIERBELL™**

**DESCRIPTION**

HGT Bell housings are designed from the ground up using 3D modelling techniques. They are rigid and robust with strength equal to or exceeding most OEM parts. OEM attachment holes and dowel positions are replicated onto model specific bellhousings. There is a hydraulic line access hole towards the top of the bell housing and an inspection window towards the bottom, these holes can be covered with removable attachment plates if desired by the user.

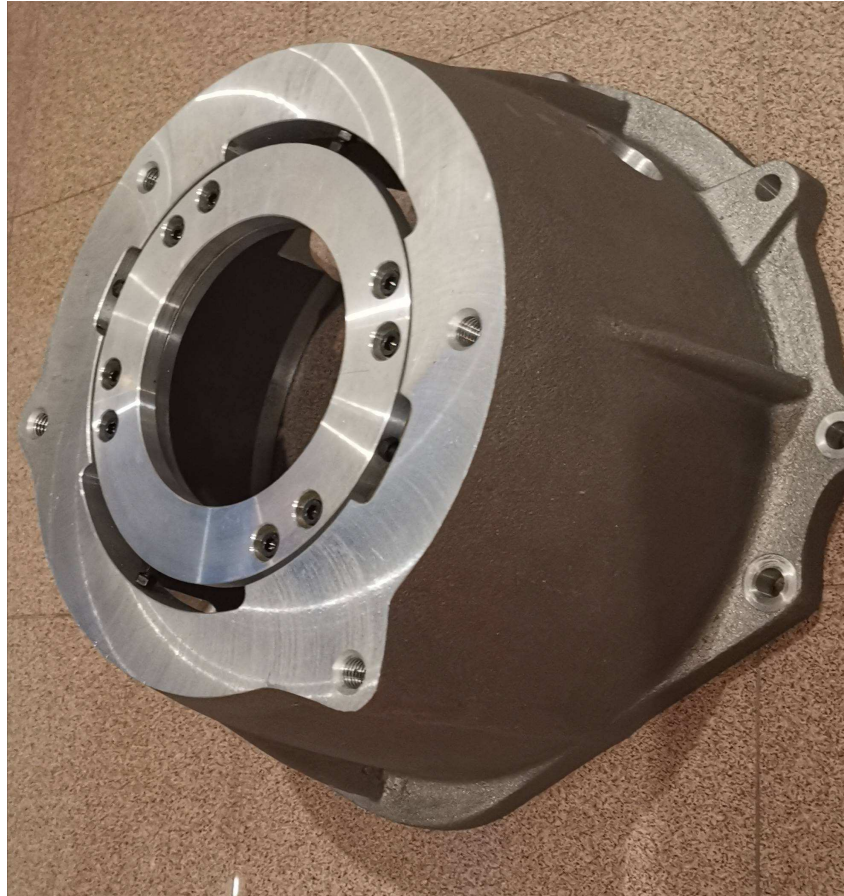
In addition, all new bellhousings are supplied with our HGT Patented Vernierbell™ adjusting ring system.

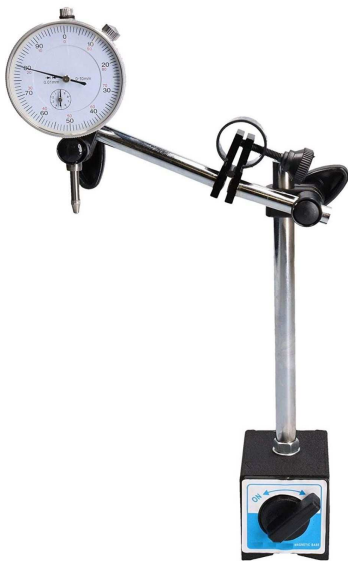
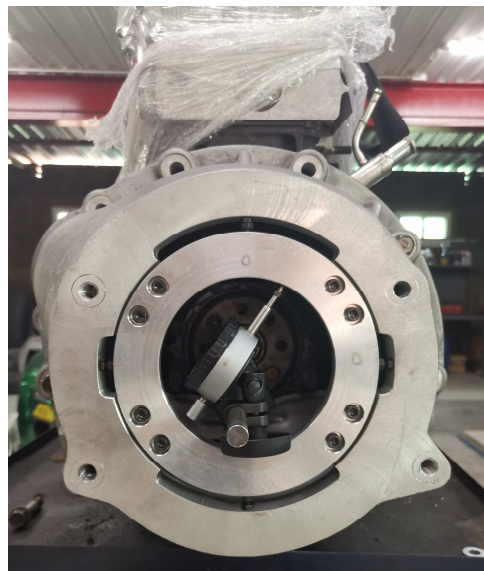
The procedure for checking the alignment of the bellhousing starts out essentially the same way as the conventional process. I.e. by using a magnetic base style dial test indicator, a "DTI", similar to that enclosed in the picture below, this being attached to the crankshaft/flywheel and rotating it  $\frac{1}{4}$  or  $\frac{1}{2}$  turn at a time. It is usually easier to have the flywheel attached in place to give a good flat metal base for the magnet to secure against. It is not necessary to have all the flywheel bolts attached for this procedure, just three will do, but do make sure the flywheel is sufficiently secure so that it does not move around during rotation of the engine.

There currently exists a wealth of information and media such as on YouTube describing the conventional procedure of bellhousing indexing. Once familiar with this procedure, you are ready to start. Keep in mind the changeover point in the indexing process starts when correctional adjustment is required. At this stage of the procedure, rather than using offset dowels to achieve the adjustment required, the Vernier system steps in and makes the adjustment task much easier to accomplish to a high degree of accuracy.

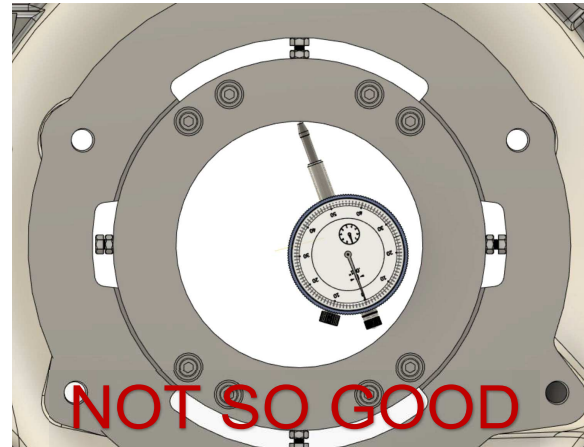
Attach the magnetic base of the DTI to the crankshaft/flywheel, use the multi part adjustable support arm of the DTI to obtain the best tip contact position, this make take a little time and patience for those unfamiliar. Placement of the DTI should be as radial as possible, avoid tangential angle if possible. Ensure the tip of the DTI is against the inner bore of the register ring. (Not the main bore of the bellhousing)
