INLAND EMPIRE DRIVELINE®

TROUBLE SHOOTING GUIDE

DRIVESHAFT DILEMMAS

GETTING RID OF THOSE BAD VIBRATIONS
By Greg Frick *Street Rodder Magazine*

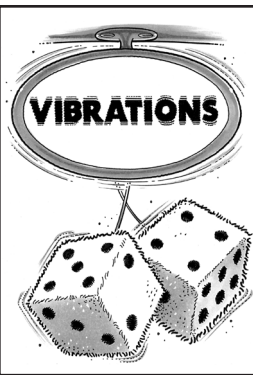
This is a very sophisticated problem that may require major changes in final drive ratios to solve.

Same action for prior problem but, if the problem persists (and it probably will, but at a different speed), change to a carbon fiber shaft. An alternative would be to change the rear end ratio and/or tire diameter to chase the problem to some speed you don't drive, but this usually defeats the purpose of having overdrive in the car.

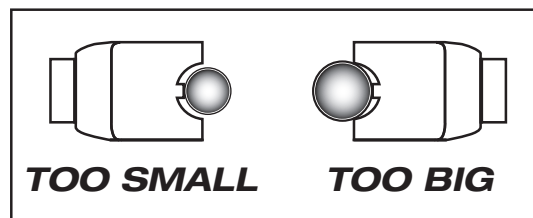
Make sure the U-Bolts holding the shaft to the pinion yoke are not too tight. Snug is different for each of us and overtightening clamps the bearing, causing drag which, in turn, causes vibration and heat.

Proper torque is 14-17 foot-pounds for 1-1/16 and 1-1/8 inch diameter caps, and 20 foot-pounds for 1-3/16 inch diameter caps. Since you can't get a torque wrench onto the U-Bolts, an approximation of these torque values is flattening the new lock washer and adding about an eighth of a turn of the nut.
