## SUBARU IMPREZA GDB – DISABLING CLUTCH ORIFICE

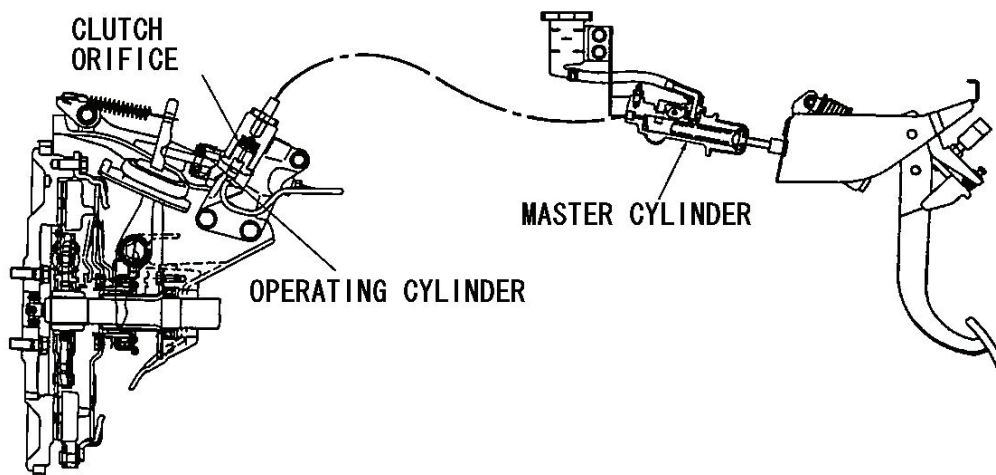
CLUTCH ORIFICE mechanism has been installed as original function in a Subaru Impreza GDB to prevent rapid clutch engagement.

However, this function may accelerate the wear rate of the carbon disc or induce slipping of the clutch, we recommend to disable the function by completing the following steps:

1. Please detach the clutch orifice, which located next to clutch operating cylinder.
2. Loosen the screw on the orifice on the operating cylinder side. **\*Please note that there are springs inside of the orifice\***
3. Remove the 2 springs as well as 2 plastic pieces from the orifice.
4. Please make sure the washer is attached to the screw and begin to tighten up the screw in order to prevent any clutch fluid from leaking.
5. Attach the orifice to the vehicle as before and bleed the clutch of air to ensure the clutch functions properly.
